Identify damage to the mixer motor on the banbury machine using the vibration method

Abstract: The Banbury mixer machine is a tool used to mix materials, such as raw rubber, carbon and chemicals into a homogeneous mixture. The Banbury engine component consists of a rotor. The rotor rotates as a result of the power transmission coming from the industrial motor, the power transmission uses a gearbox. Therefore, induction motors play an important role in Banbury engines. If damage to the induction motor is not detected early, it can result in more severe damage or even unusability. Therefore, in this paper we will analyze the characteristics of bearing damage using the Fast Fourier Transform (FFT) method and the Hilbert method on mixer motors. The bearings used in the mixer motor are SKF 6330/C3 bearings in the drive end position and SKF 6324 types in the non-drive end motor position. The measurement results were then processed using the Fast Fourier Transform (FFT) and Hilbert Transform methods. The rotation speed variations carried out in the test were 500 rpm, 1000 rpm and 1500 rpm. Bearing damage analysis uses a vibration method that is obtained based on characteristic frequency

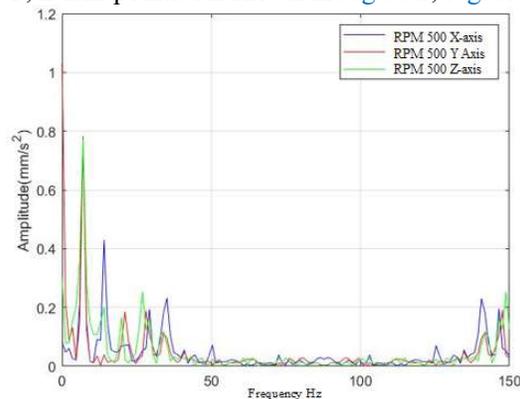
Figure 2. Graph of vibration signal of X,Y,Z axes at 500 RPM

[Figure 2](#) is a graph of the results of measuring vibration signals on the X, Y, Z axes at a speed of 500 RPM. It can be seen that the average amplitude that appears is 0.2 mm/s² with the highest value being 0.78 mm/s² and there is no amplitude that appears close to the damage frequency value.

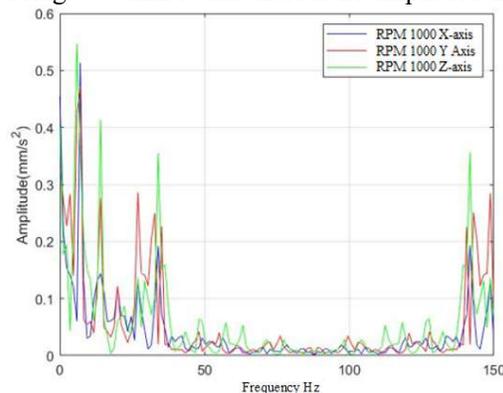
Figure 3. Graph of vibration signals for the X,Y,Z axes at 1000 RPM

Figure 3 is a graph of the results of measuring vibration signals on the X, Y, Z axes at a speed of 1000 RPM. It can be seen that the average amplitude that appears is 0.29 mm/s^2 with the highest value being 0.55 mm/s^2 and there is no amplitude that appears close to the damage frequency value.

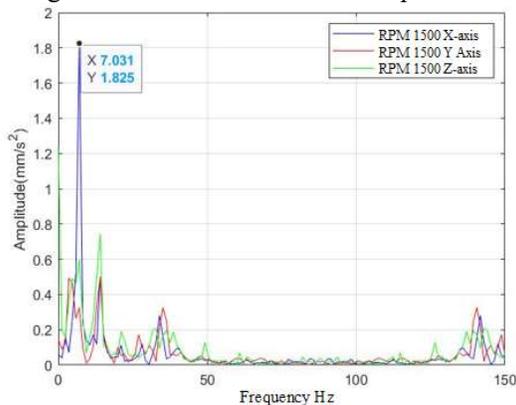
Figure 4. Graph of vibration signals for the X,Y,Z axes at 1500 RPM

Figure 4 above shows that the resulting amplitude value increases as a result of the experimental variations given. In this case it can be seen that at 1500 rpm (X Axis Point = 7,031 Hz) the amplitude graph is closest to the bearing damage limit compared to the other axis points.

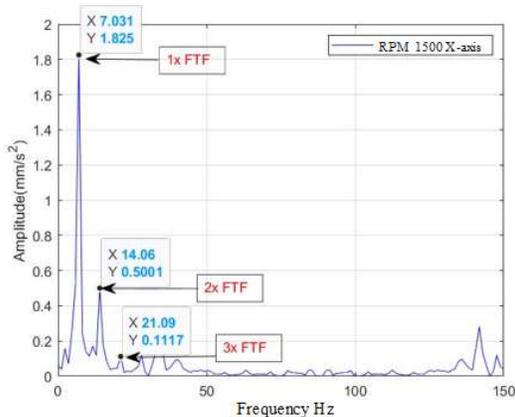
Figure 5. X-axis vibration signal graph at 1500 RPM

Figure 5, the vibration signal graphic data at point Theoretically, the calculation of 1xFTF is 7.79 as shown in Table 1, while the harmonics which include 2xFTF and 3xFTF are 14.06 Hz and 21.09 Hz respectively. This indicates that the bearing in the drive end position, namely the SKF 6330/C3 bearing, is thought to have experienced damage to the cage bearing (ball bearing cage). So the action taken is to replace the bearing with a new one as soon as possible.

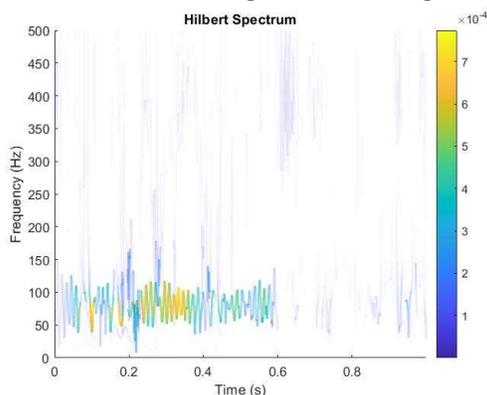
Figure 6. X-axis Hilbert spectrum at 1500 RPM

Figure 6, is a graphic spectrum of the X axis at a speed of 1500 RPM which was analyzed using the Hilbert method with the Matlab application. It can be seen that the average frequency of the energy produced is 98 Hz, and it can also be seen that the resulting graph is a non-linear graph which indicates that at that point damage has occurred.

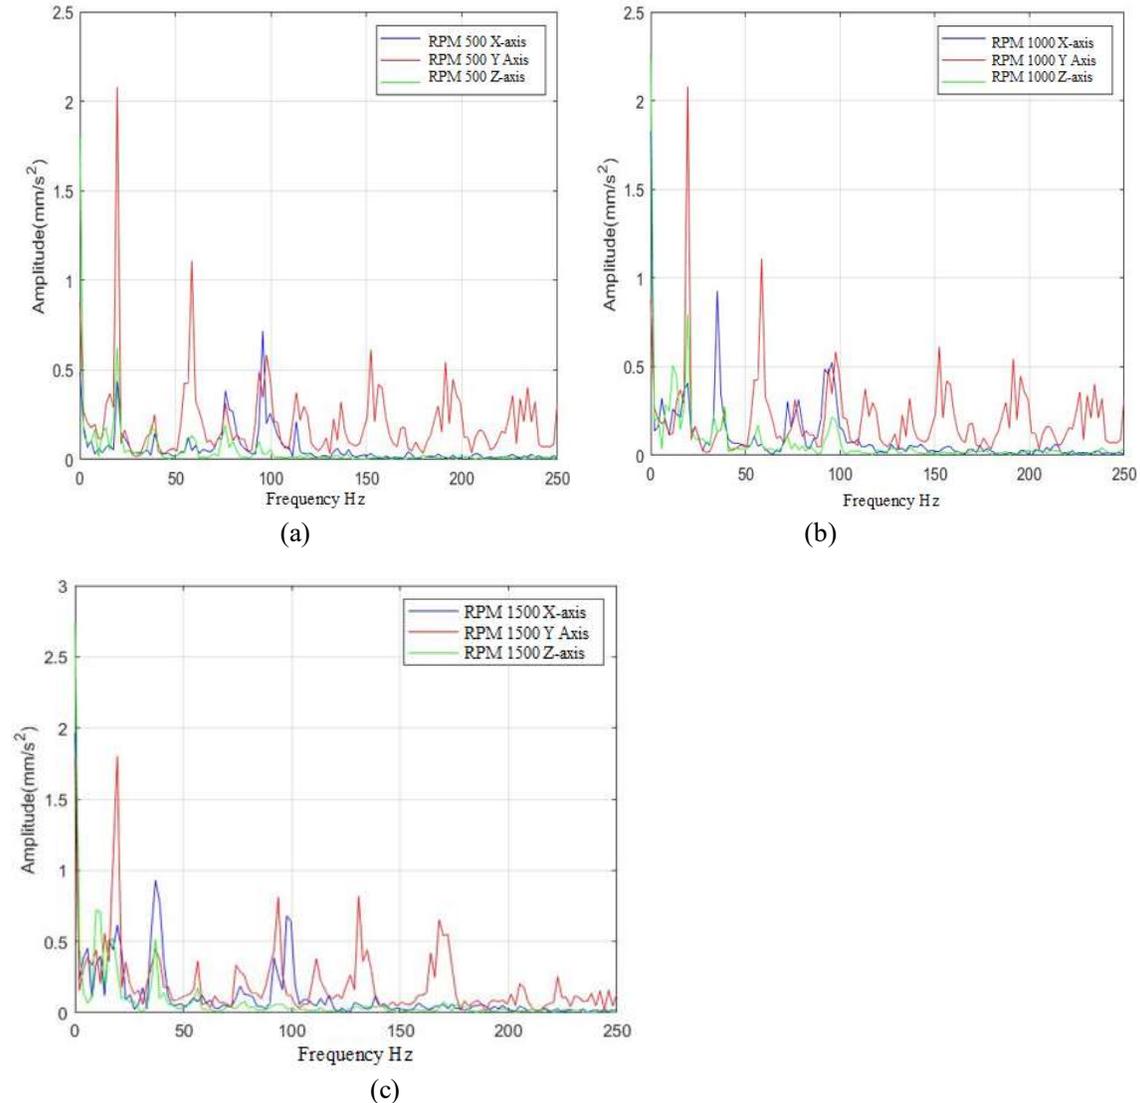
Figure 7. (a). Vibration signal graph at 500 RPM, (b). Vibration signal graph at 1000 RPM, (c). Vibration signal graph at 1500 RPM

From the results of the graphic analysis in Figure 7, overall it can be seen that several amplitudes with high values appear. However, from this amplitude there are no frequencies that appear at the theoretically calculated bearing damage frequency as in Table 2, or around that frequency. This is because not all high amplitudes indicate that damage has occurred to the bearing. The bearing damage frequency value is estimated to only appear around the damage frequency value that has been calculated theoretically. This high amplitude may be caused by dust entering the bearing components, causing friction between the steel balls or other noise. Therefore, it can be concluded that the overall condition of the rear or non-drive end bearings, namely SKF 6324 bearings, is still in good condition and there has been no damage.

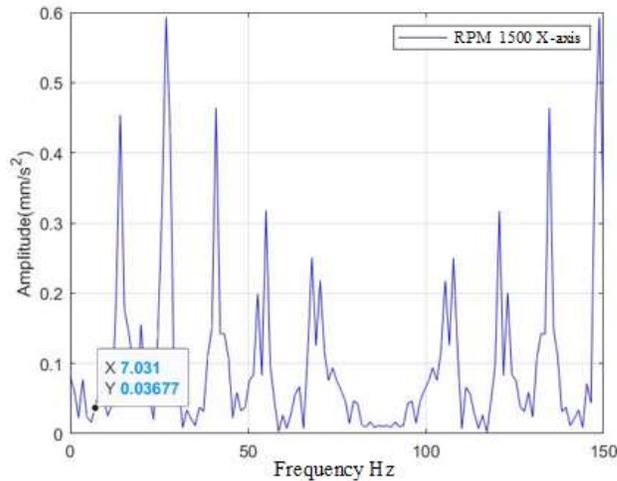
Figure 8. X-axis vibration signal graph at 1500 RPM after repair

The picture above you can see vibration data on the X axis at 1500 rpm after repair. As a result of carrying out repairs to the bearing replacement, the peak amplitude value experienced a very significant decrease from the initial amplitude before the repair of 1.825 Hz (seen in Figure 5) to a value of 0.0367 Hz (Figure 8). And at the values of 1x FTF, 1x BSF, 1x BPFO, and 1x BPFI, by observing Table 1, nothing is close to the bearing damage limit. So that the repair process in the form of bearing replacement is successful.

After repairing the replacement of the front bearing, namely the SKF 6330/C3 bearing, the motorbike was set up again as before. Then the vibration data is taken again using the same method. The following are the results of vibration data after bearing replacement repairs:

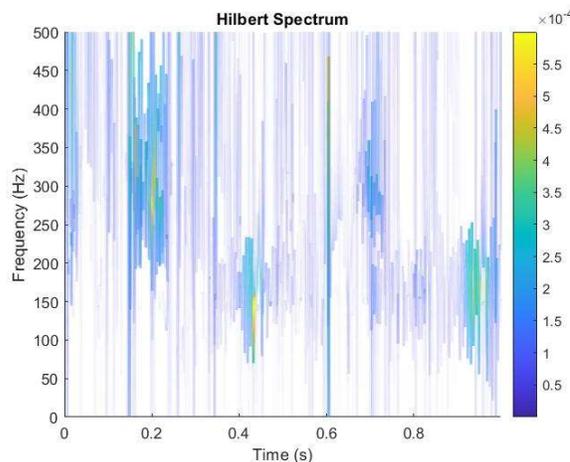
Figure 9. X-axis Hilbert spectrum at 1500 RPM after improvement

Figure 9, a graph of the x-axis Hilbert spectrum is shown at a speed of 1500 with conditions after bearing replacement. A spectrum pattern can be seen that is different from the condition before repair (Figure 1), where the resulting graph is a linear graph which indicates that at that point there is no indication of damage.
