## Analysis of the impact of misfiring on the throttle body in Ayla vehicles using the fast fourier transform method

**Abstract:** An essential component of an automobile's air intake system, the throttle body controls airflow during combustion by acting as an idle speed control mechanism. Making ensuring the throttle body is operating properly is crucial to keeping the engine running at its best. The Fast Fourier Transform vibration analysis is one technique used for this (FFT). A an LCGC Ayla 1000 cc vehicle's throttle body and engine underwent vibration testing with rotational rates set to 750 rpm, 1000 rpm, 1500 rpm, and 2000 rpm. Vibration responses were measured using an accelerometer sensor coupled to an FFT analyzer, and Matlab was used for analysis. The throttle body had anomalous frequency readings at 1977 Hz with an amplitude of 0.03171 m/s<sup>2</sup>, according to the test results. On the other hand, the frequency value at 1410 Hz with an amplitude of 0.03435 m/s<sup>2</sup> was observed under normal circumstances. Similar to this, abnormal frequency values with an amplitude of 0.02378 m/s<sup>2</sup> were found on the engine at 1493 Hz, whereas normal frequency value

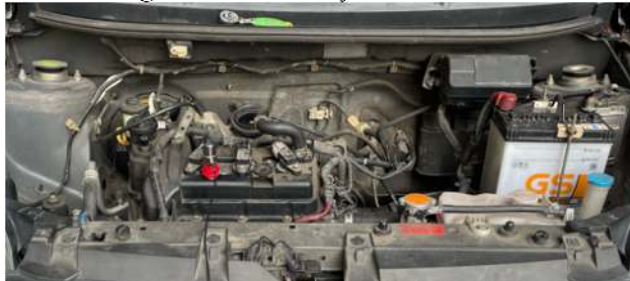
[Figure 2](#). Ayla 1000cc engine.

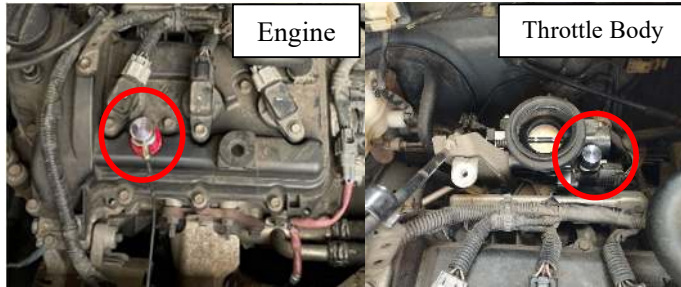
Figure 3. Placement of vibration accelerometer sensors.

[Figure 3](#). shows the measurement spots on the LCGC Ayla 1000cc engine and the throttle body. The vibration values are measured using the FFT Analyzer. As seen in [Figure 4](#) data evaluation is done using Matlab R2020a.

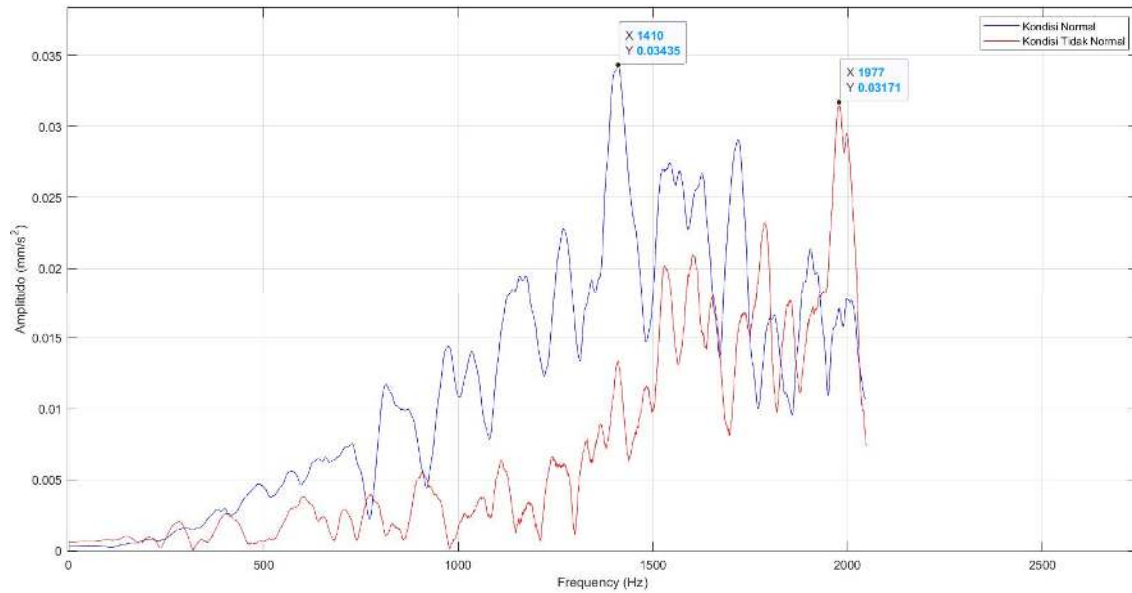
An accelerometer sensor and FFT analyzer were mounted on the engine and throttle body, and the engine was rotated at four different speeds: 750, 1000, 1600, and 2000 rpm [16]. Under typical circumstances, the throttle body test results revealed a frequency value of 1410 Hz and an amplitude of 0.03435 m/s<sup>2</sup>. On the other hand, 1977 Hz with an amplitude of 0.03171 m/s<sup>2</sup> was the frequency value achieved under abnormal conditions. While the drop in amplitude indicates a loss in power or disturbances in the throttle body mechanism, particularly in idle speed control, the rise in frequency could be caused by several factors such as wear, leakage, or dirt buildup within the throttle body [18]. This is depicted in Figure 6.

Figure 6. FFT results of the throttle body in normal and abnormal conditions at 1000 rpm rotation speed.

Combining frequency normal and abnormal circumstances shown in FFT form, the analysis of throttle body damage was carried out, producing 35 mode shapes. Local and global frequencies that are visible on the throttle body can be seen on the graph. The graph clearly shows that the abnormal state, which is brought on by the idle speed control shaft mechanism, is lower than the usual frequency, as Table 3 makes clear.
