Analysis of the corrosion rate and remaining life of the B3 waste transport roll-off tank composed of 316L stainless steel

Abstract. Corrosion has eroded the shell and head of the roll-off tank used to carry B3 waste. This influence will effect on the functioning of the waste containment tanks, as well as the general safety of the public. The goal of this study was to examine the viability of employing a roll off tank by completing a visual inspection and engineering calculations using ASME VIII and API 510 standards to determine the corrosion rate and remaining life in the roll-off tank. This study employs a quantitative approach. Tank design data was acquired using SA-240/G316L material with an initial shell and head thickness of 6 mm and an actual thickness of 5.45 mm shell and 5.50 mm head. The corrosion rate and remaining life analysis yielded a Thickness Required shell value of 4.33 mm and a head value of 4.33 mm, with a shell and head Corrosion Rate value of 0.04 mpy, a Maximum Allowable Working Pressure (MAWP) value of shell and head of 0.63 Bar, and a shell and head remaining life value of 28 years and 30 years, respectively. It may be established that the roll-off tank i

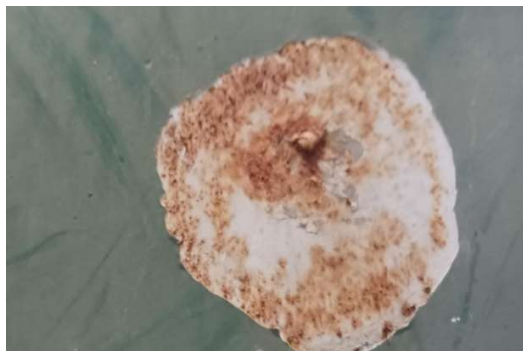
Visual inspection is one of the NDT (Non-Destructive Testing) methods for evaluating conditions and providing quality comparisons of workpieces to be tested against applicable standards [14]. An ultrasonic thickness gauge is one of the tools used in visual inspection to evaluate the thickness of metal material [14]. The maintenance department, as the supervisor of maintenance operational activities, performs the visual inspection procedure. Checking the condition of the roll off tank entails inspecting the existing tank and using an ultrasonic thickness gauge to measure the thickness of the shell and tank head [6]. In checking the condition of the existing tank, uniform corrosion spots were found on the head rear at the 90° point as shown in **Figure 2**, and damage to the paint coating on the surface of the tank shell as shown in **Figure 3**.

Figure 2. Uniform rust on the tank head

The visual inspection revealed damage to the tank in the form of uniform corrosion at the head rear point of 90°. As well as damage in the form of scratches on the paint coating on the surface of the tank shell. The engineering calculation revealed that the roll off tank was still categorized as feasible to operate due to the value of the shell thickness and the permitted head being less than the actual thickness. Namely the shell (4.33 mm 5.45 mm) and head (4.33 mm 5.50 mm), with a Corrosion Rate value of shell (0.04 mpy) and head (0.04 mpy), Maximum Allowable Working Pressure (MAWP) value of shell (6.3 Bar) and head (6.3 Bar), and remaining life value of 28 years, implying that the roll off tank can still operate for another 28 years.

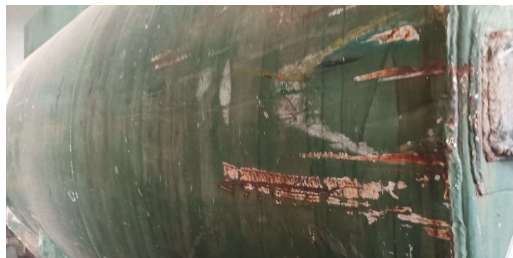
Figure 3. Scratches on the tank's paint covering

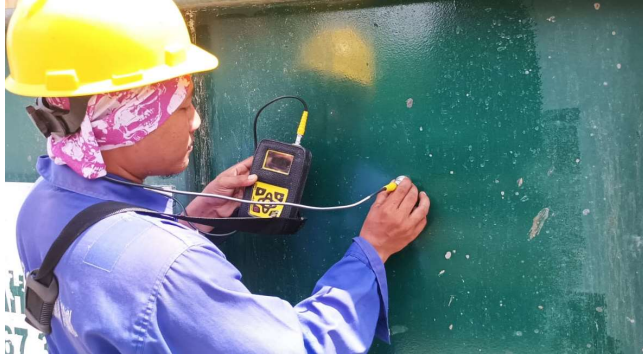
There are 18 test points in the process of checking the thickness of the shell and tank head using an ultrasonic thickness gauge, as shown in **Figure 4**. **Figure 5** namely shell 1, 2, and 3 with point degrees of 0°, 90°, 180°, and 270°, and on the head front and head rear with point degrees of 0°, 90°, 180°. **Table 1** shows how to collect actual data on the status of the plate thickness in the roll off tank.

Figure 4. An ultrasonic thickness gauge is used in the inspection process

Figure 5. Thickness data collecting points sketch

According to **Table 1**, the smallest thickness for shell is found in shell 2 and shell 3 with location points of 90°, 180°, and 270° and a measurement value of 5.45 mm, while the thickness of the head is found in head 1 with location points of 90°, 180°, and 180° and a measurement value of 5.50 mm.
