Identification of ignition system coil damage on MPV 1000 CC vehicle using fast fourier transform

Abstract: The coil is the main component of the vehicle in the ignition system. So that the coil can continue to function correctly, it is vital to plan ahead and maintain its performance. One method that can be done is the vibration method. Vibration testing was carried out on a 1000 cc MPV vehicle with rotational variations of 800 rpm, 1500 rpm, 2500 rpm and 3500 rpm. Vibration testing is carried out using an accelerometer sensor connected to the FFT Analyzer to measure the vibration response, then an analysis is carried out using Matlab. From the research results obtained at the Y-axis point with a rotating speed of 1500 rpm the first shape mode appears at a frequency of 45 Hz with an amplitude of 1.357 mm/s² under normal conditions. Whereas in abnormal conditions the first shape mode appears at a frequency of 41 Hz with an amplitude of 1,944 mm/s². In abnormal conditions, damage due to bearing defects is obtained, this is due to the discovery of a frequency of 4x rpm at 1500 rpm rotation. Furthermore, at a rotational speed of 2500 rpm the measurement results on the engine show tha

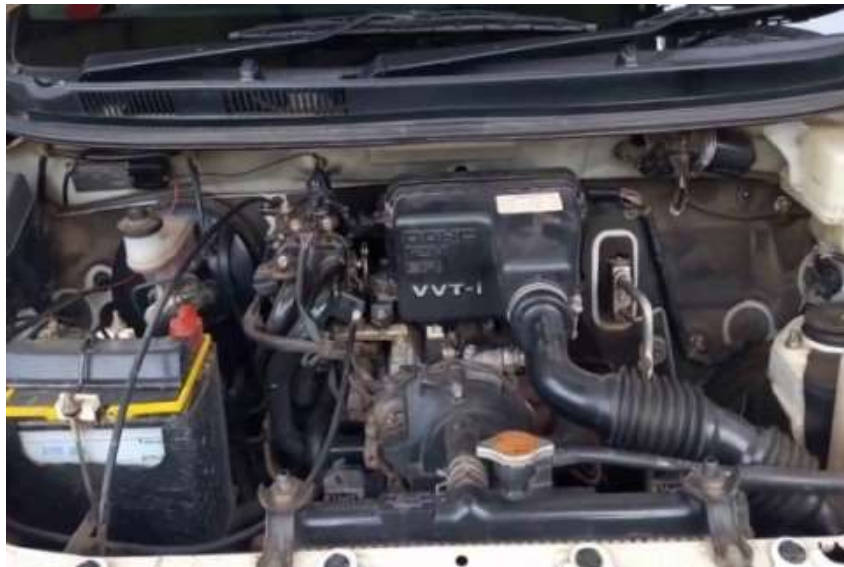
Figure 2. A 1000 cc piston-powered MPV

A test plan was executed in advance of the test employing a different rotational speed for the 1000 cc MPV engine. Place the accelerometer sensor, which has three points: axis (X), axis (Y), and axis (Z), on the engine of the car before testing. A BNC cable is used to connect the accelerometer sensor to the FFT Analyzer. There are four different engine speed ranges that are used: 800, 1500, 2500, and 3500 rpm. Matlab was used to evaluate the FFT Analyzer's measurement results. The MPV 1000 cc piston motor is depicted in **Figure 2**. **Table 1** lists the specs for 1000 cc MPV automobiles.

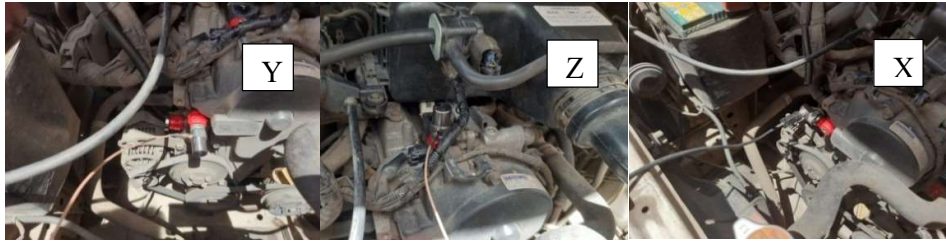
Figure 3. Placement of Axis Points (X), (Y) and (Z)

A study was done to find out the characteristics of the vibrations that happen at these three sites under both normal and damaged coil situations by positioning the sensors at the (X), (Y), and (Z) axes. The investigation was conducted with the equipment in a static state.

The measurement sites on a 1000 cc Mpv piston engine are shown in **Figure 3**. Additionally, the FFT Analyzer is used to measure the resulting vibration response. Matlab was used to evaluate the data, as shown in **Figure 4**.

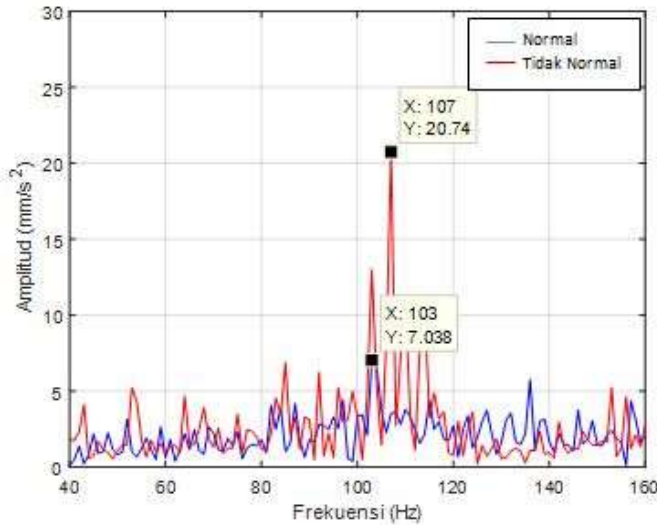
Figure 7 displays a graph of the FFT findings on the axis (Y) at a 2500 rpm rotating speed. According to the engine's test data, under typical coil settings, the first form mode manifests at a frequency of 48 Hz and an amplitude of 2,256 mm/s². In the meantime, a form mode with a frequency of 41 Hz and an amplitude of 4,176 mm/s² manifests under abnormal circumstances. Under normal circumstances, the frequency of 82 Hz that is visible does not exist. Because it happens at a 2x rpm, this illustrates the presence of losses.

Figure 7. FFT results for normal and abnormal coil conditions with a rotation speed of 2500 rpm

As indicated in Table 4, global frequencies occur at frequencies of 75 Hz and 103 Hz while local frequencies in abnormal conditions occur at frequencies of 41 Hz, 54 Hz, 64 Hz, 68 Hz, 85 Hz, 107 Hz, 114 Hz, 124 Hz, 142 Hz, and 156 Hz. Figure 6's amplitude peaks are used to create Table 4.

Table 4 demonstrates that there are losses caused by damage to the ignition system coil at a rotational speed of 2500 rpm. This is demonstrated by the emergence of 2x rpm, which is equal to 82 Hz. Additionally, the measurement yields a global frequency that oscillates between 75 Hz and 103 Hz. In contrast, **Table 3** shows that under abnormal circumstances, at a rotational speed of 1500 rpm, there is a frequency of 4x rpm that denotes the onset of a bearing defect. The frequency at which the global frequency manifests is 61 Hz.
