Analysis of crack defects in the hanger welding area using the DMAIC method in the heavy equipment industry

Keywords: Defect crack; hanger welding; DMAIC method

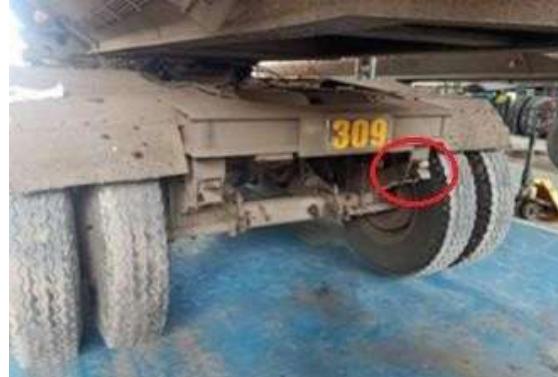
Figure 3. Hanger welding defect

Based on the data collection that has been carried out, this section will analyze the causes of the type of broken front hanger problem that occurs in Semi-Trailer Side Tipper (SST) and Dolly units. Based on data on problems that occurred in 2022, defect welding cracks in the hanger area did not occur in all trailer units. This indicates that the problems that occur in the hanger area are not caused by the construction design made by engineering. The hanger defect can be seen in Figure 3.

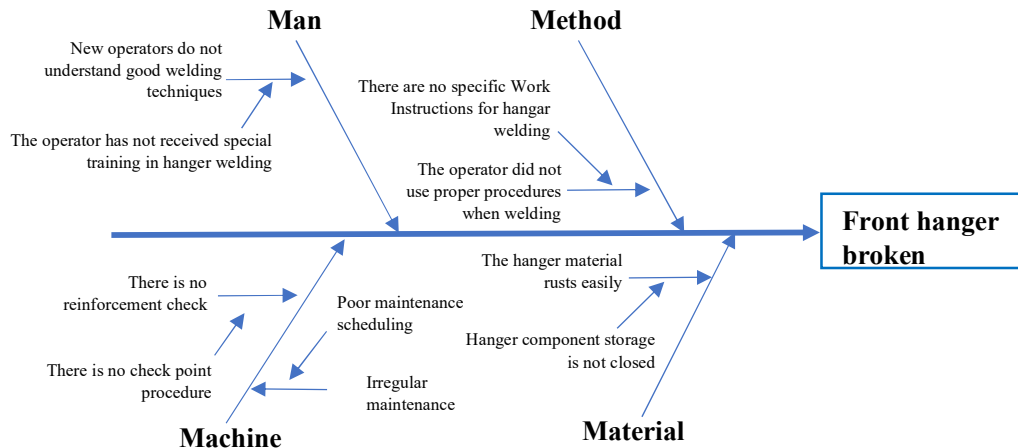
Figure 4. Fishbone diagram of front hanger broken

Based on data analysis of current conditions, the research concludes that the roots that cause crack defects in the hanger welding area are presented in a fishbone diagram. The fishbone diagram can be seen in Figure 4.

After finding the root of the problem, a repair plan is then carried out to overcome the problem of welding defects in the hanger welding area so that similar problems do not occur again.

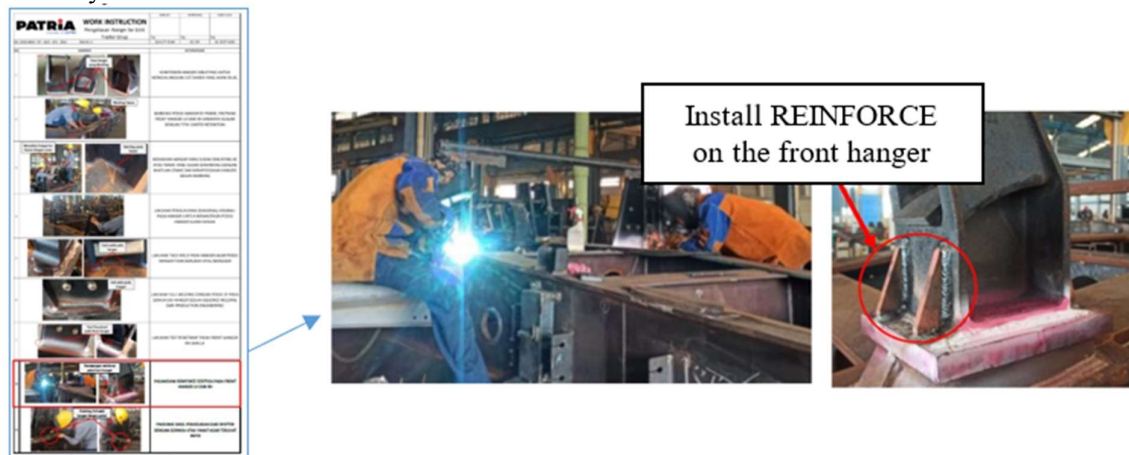
Figure 5. Hanger welding work instructions

After analyzing the related problems, a work instruction was created regarding the process of fabricating the hanger to the unit so that there would be no more missed processes when installing the hanger and to make it easier for new operators to understand the sequence of the process of attaching the hanger to the bottom flange frame. The work instruction in Figure 5 explains the sequence of the process of attaching the hanger to the bottom flange frame, there are pictures and descriptions of the process carried out to make it easier to understand the work instruction. Reinforcement installation is included in the work instructions to remind the operator so that this process is not missed again. Detail of work instruction can be seen in Figure 5.

At this time, operators working on the trailer unit fabrication line know the flow of the hanger installation process based on information obtained visually by the previous operator. So the operator does not understand exactly what process should be carried out. In fact, the problem of the hanger detaching from the frame is due to the operator's negligence in not carrying out the process sequence correctly.
